Quarterly Water Quality Report

June 2022 to August 2022

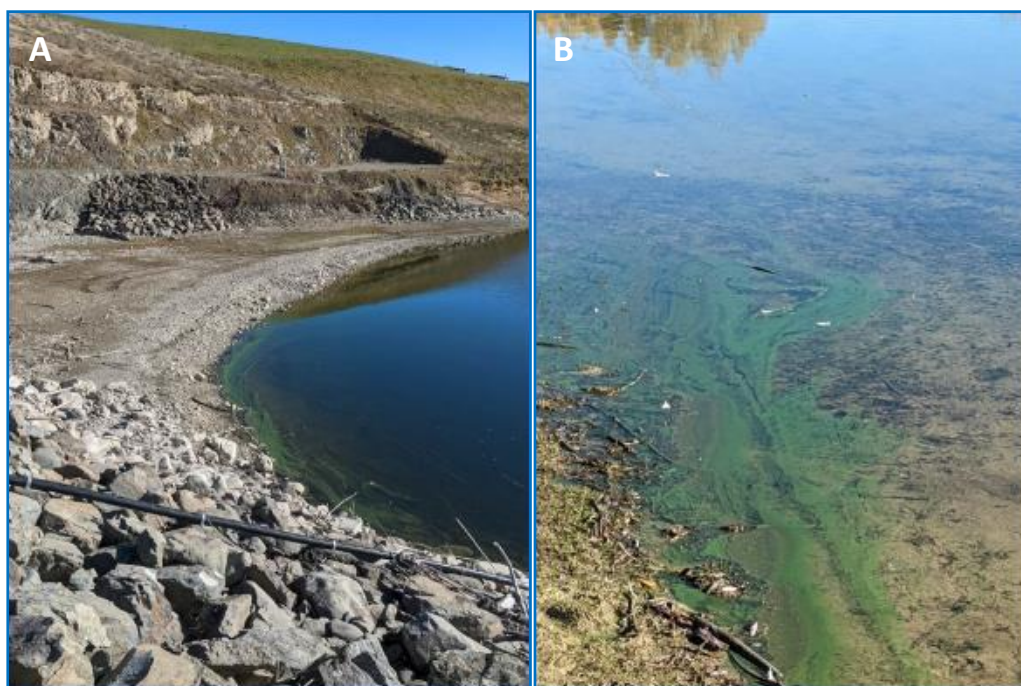
In May 2022, a **cyanobacteria** alert was issued for Lake Opuha due to the presence of scums which were identified as *Woronichinia naegeliiana* (Figure 3). The scums were observed at Ewerts Boat Ramp, Bennetts Recreational Reserve Boat Ramp, Dam Boat Ramp and along the dam wall. The cyanobacteria persisted until mid-July when increased inflows and turbidity in the lake caused the cyanobacteria to dissipate. The cyanobacteria alert for Lake Opuha was removed on 29 August 2022 – 94 days after it was issued.

Figure 3: Cyanobacteria scums at A) Dam boat ramp area and B) Bennetts recreation reserve boat ramp, on 16 May 2022.

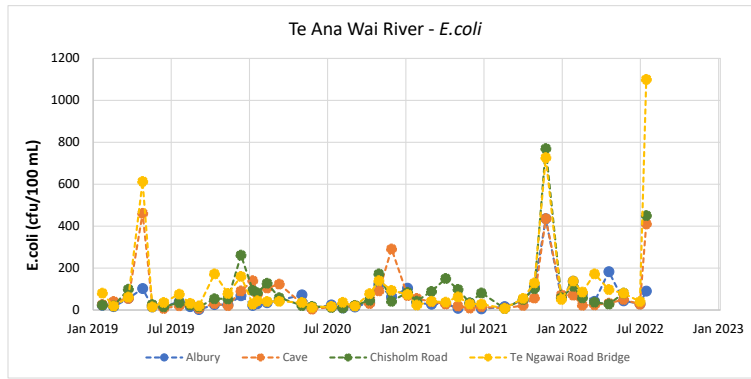
E.coli sampling on 8th August 2022 showed elevated levels across all sampling locations (Figure 10). *E.coli* levels increased from the most upstream location (Albury – 90 cfu/100 mL) to the most downstream location (Te Ngawai Road Bridge – 1,100 cfu/100 mL). In the 48 hours prior to sampling, 37 mm of rainfall was recorded at the Mackenzie Pass rain gauge and 29 mm of rainfall was recorded at the Opihi rain gauge. Peak flow was recorded on 6th August 2022 (79 m³/s) and at the time of sampling the flow was 20 m³/s.

Analysis of all data since 2019 shows that, overall, the Te Ana Wai River has achieved NPS Band A status for *E.coli*, indicating that the risk of infection from contact recreation is low.

Figure 10: E.coli levels in the Te Ana Wai River since 2019.
