## Quarterly Water Quality Report

September 2022 to December 2022

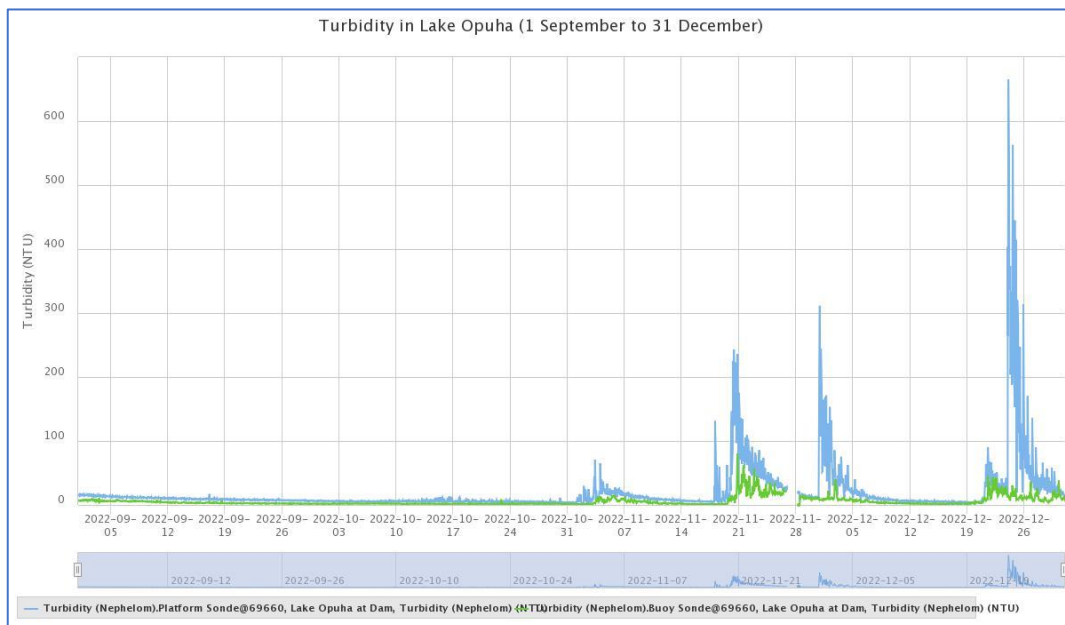
**Turbidity** within the lake is typically below 10 NTU and is often less than 5 NTU. Figure 1 shows the turbidity in Lake Opuha from 1 September 2022 to 31 December 2022. During September and most of October, the turbidity in Lake Opuha was reasonably stable with the turbidity at depth varying between 2– 15 NTU. During this time, there were rain events up to 12 mm/day (as measured at Dobson Ski Area and Fox Peak Ski Area) but the turbidity did not increase significantly. Between 31 October and 31 December there were four rain events which resulted in increased turbidity in Lake Opuha. Turbidity increased at both the surface (–) and at depth (–), but the greatest increase in turbidity occurs at depth due to the cooler inflows travelling along the bottom of the lake and not mixing with the warmer water at the top of the lake. The rainfall record for the four rain events and the maximum turbidity values are given in Table 1.

Figure 1: Turbidity in Lake Opuha at surface (–) and depth (–).

Table 1: Rain events showing rainfall at Fox Peak Ski Area and Dobson Ski Area and associated maximum turbidity values in Lake Opuha at depth.

Rain Event	Date	Fox Peak Rainfall (mm)	Dobson Rainfall (mm)	Maximum Turbidity (NTU)	Days for turbidity to return to ~10 NTU <sup>1</sup>
1	31 October	11	33	50 – 70	9
	2 November	70	42		
2	16 November	22	13	200 – 250	13
	17 November	10	45		
	18 November	8	11		
	19 November	60	63		
3	30 November	12	35	250 – 350	7
4	18 December	27	19	500 – 650	13
	19 December	17	15		
	20 December	41	40

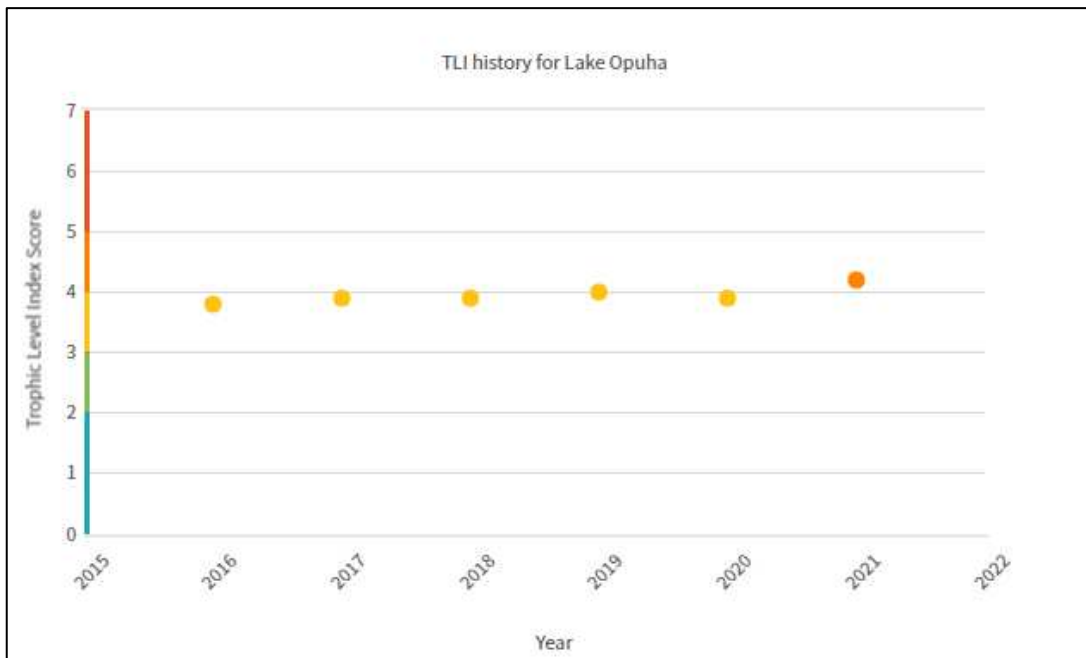
Both ECan and OWL collect data to calculate the TLI for Lake Opuha. From December to April/May each year, ECan undertake monthly sampling via helicopter to calculate an annual TLI score. Figure 2 shows the TLI scores from 2016 to 2021, calculated from ECan’s data (OWL’s data shows similar scores). The TLI scores have been reasonably consistent since 2016 with scores ranging from 3.8 to 4.2. From 2016 to 2020 the TLI score was classified as *FAIR* and in 2021 the TLI score was classified as *POOR*.

Figure 2: TLI scores for Lake Opuha based on ECan data (<https://www.lawa.org.nz/explore-data/canterbury-region/lakes/lake-opuha/>)

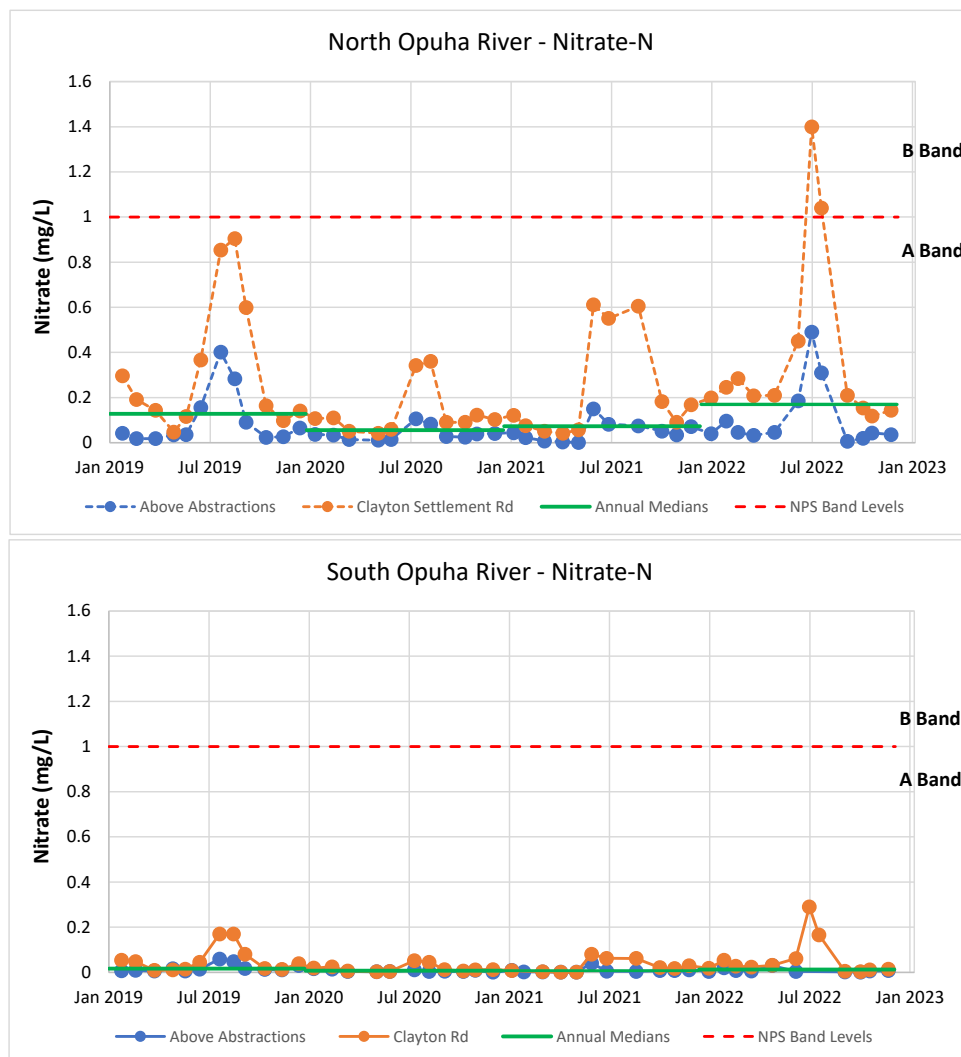
Increased **nitrate** levels were observed in the Lake Opuha tributaries over the 2022 June – August period due to increased inflows. Monitoring over the 2022 September – December period has shown that nitrate levels have decreased and returned to expected levels, as shown for the North Opuha River and the South Opuha River in Figure 3. This behaviour was typical of all of tributaries of Lake Opuha during the 2022 September – December period.

Figure 3: Nitrate levels in the North Opuha River and South Opuha River.

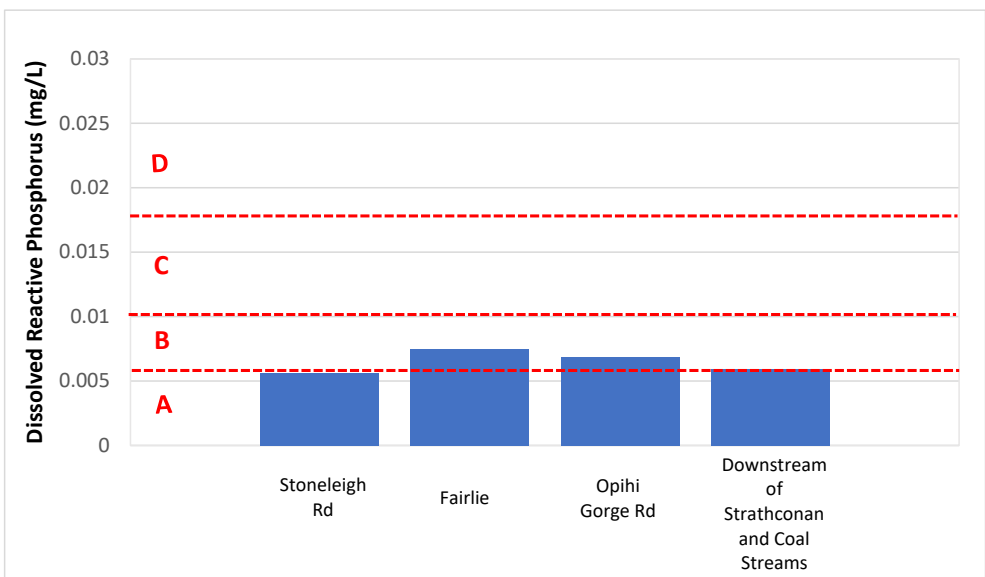
Monitoring of DRP also occurs at four locations on the Upper Opihi River. Figure 5 shows the median DRP levels at the four sampling locations from upstream to downstream – Stoneleigh Rd, Fairlie, Opihi Gorge Rd and Downstream of Strathconan and Coal Streams. Stoneleigh Rd and Downstream of Strathconan and Coal Streams achieve A Band status, whereas Fairlie and Opihi Gorge Rd comfortably achieve B band status. Although there are some high DRP levels in the tributaries of the Upper Opihi River, the current DRP levels at the Upper Opihi River monitoring sites are reasonably low. These sites will continue to be monitored to observe if there is any increase over time.

Figure 5: Median DRP levels for 2022 for sampling sites on the Upper Opihi River and comparison to NPS Band Levels (----).

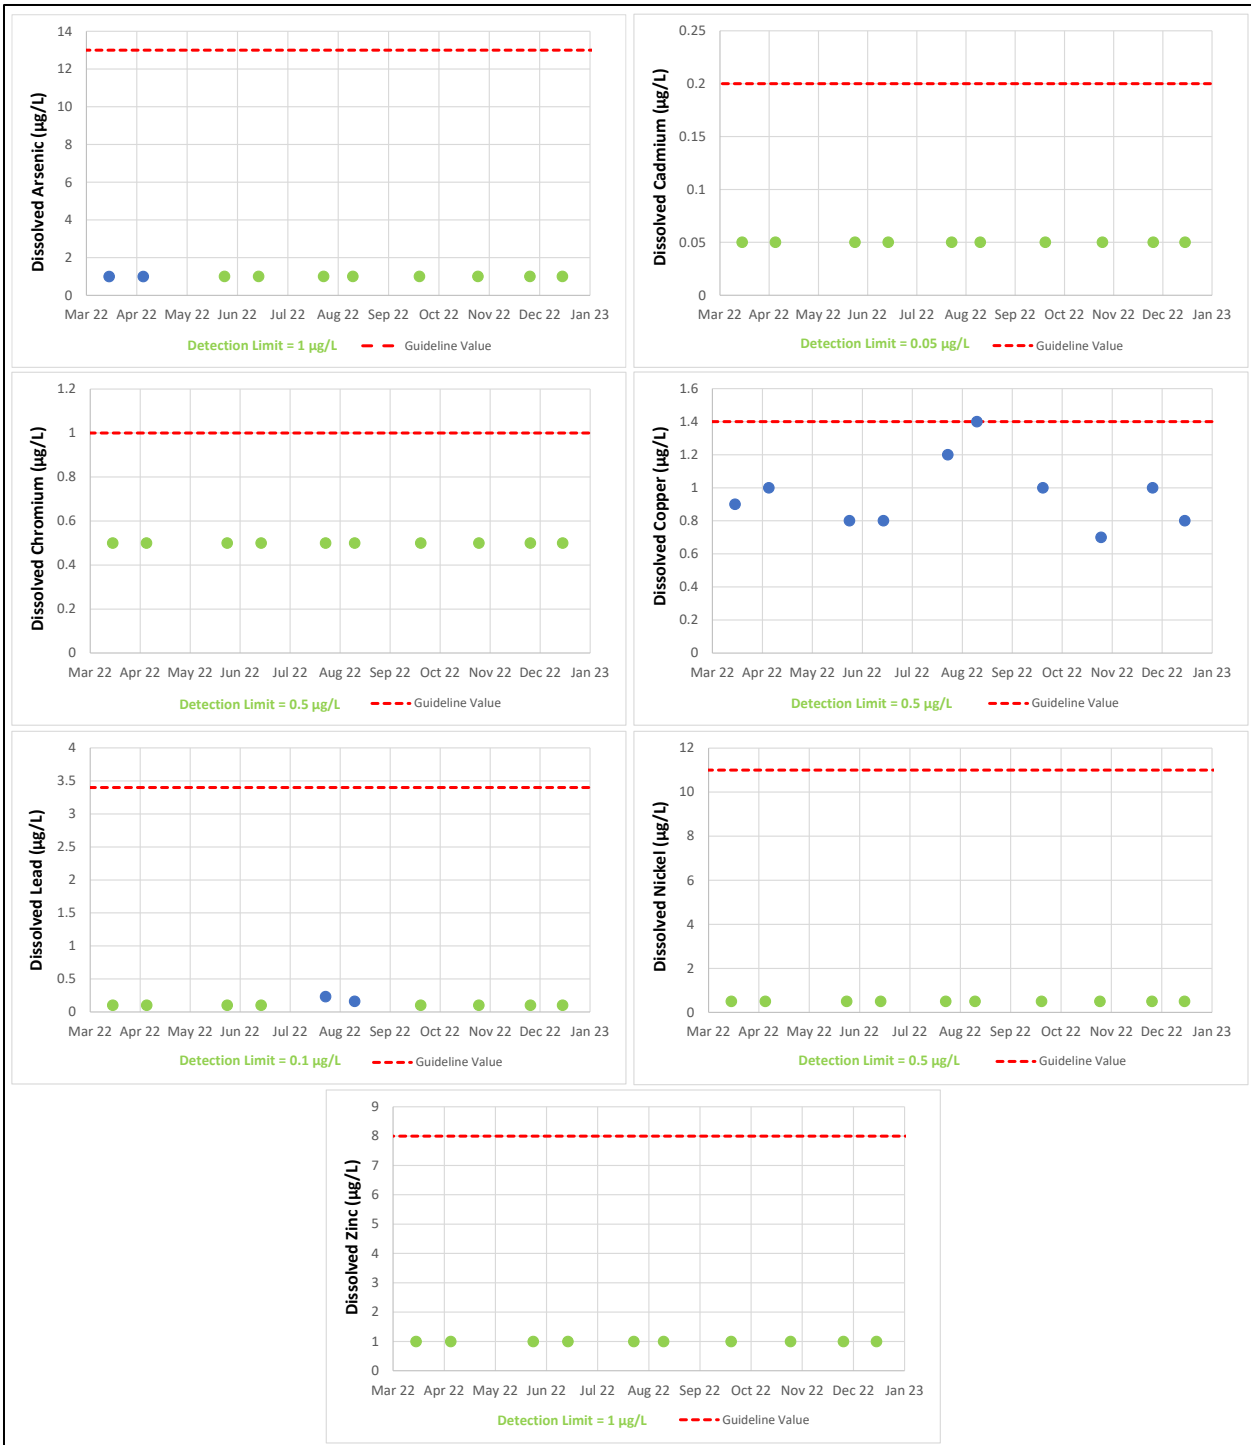
Figure 6 and Figure 7 shows the total metal and dissolved metal results, respectively, for below the Downstream Weir. Green data is data that is less than the laboratory detection limit whereas blue data is data that is above the laboratory detection limit. For example, the total metal data for cadmium shows that all values were less than the laboratory detection limit whereas the total metal data for copper shows that all values were above the laboratory detection limit.

As mentioned above, if any total metals exceed GV then the dissolved fraction should be compared to GV to understand any potential ecological effects as the dissolved fraction is more aligned with the toxic fraction. All dissolved metal concentrations were less than the GV with the exception of copper in August which was at the same level as the GV. Collectively, these results indicate that the ecological risk from heavy metals in the Opuha River is considered low.

Figure 7: Dissolved metal results for arsenic, cadmium, chromium, copper, lead, nickel and zinc for the Opuha River below the Downstream Weir and comparison to guideline value (-----). Green dots (■) indicate values less than the detection limit and blue dots (■) indicate values above the detection limit.
