Quarterly Water Quality Report

April 2023 to June 2023

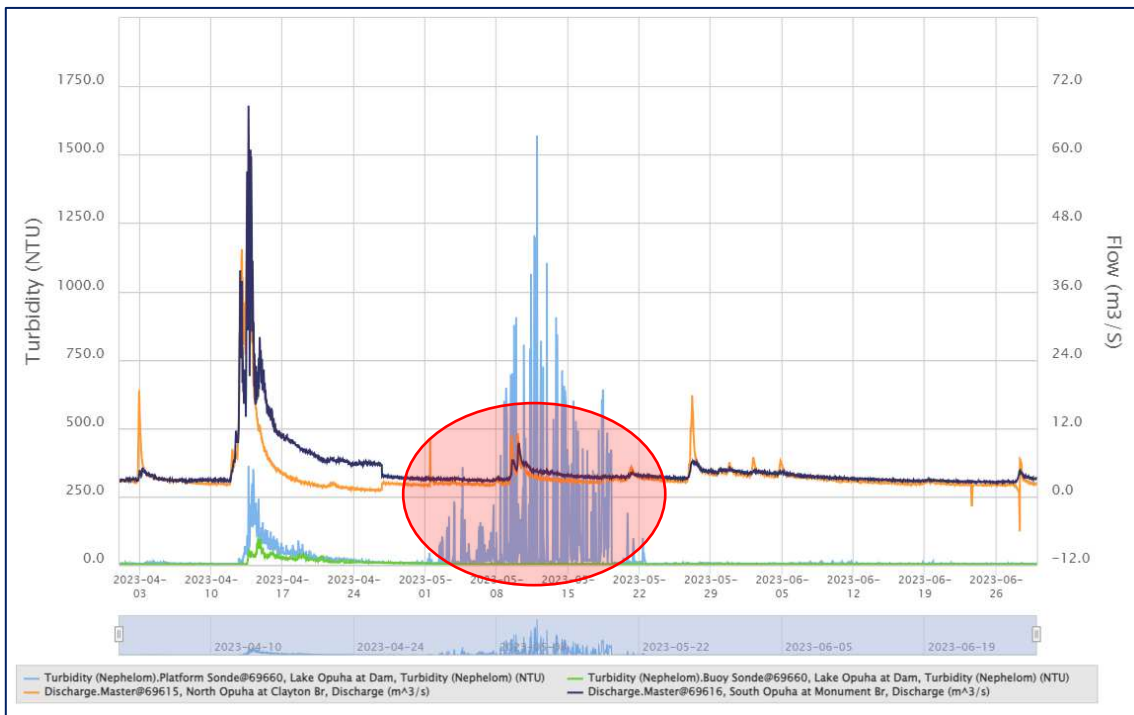
Figure 1: Turbidity in Lake Opuha (depth and surface) and flows from the North Opuha and South Opuha rivers from 1 April 2023 to 30 June 2023.

Turbidity is a water quality parameter that is easily measured and gives insight into the amount of suspended sediment in a waterway and the visual clarity of the water. Increased turbidity generally corresponds to decreased visual water clarity. Turbidity within Lake Opuha is typically below 5 NTU, unless there is a rain event within the catchment. Figure 1 illustrates the turbidity in Lake Opuha from 1 April 2023 to 30 June 2023 along with the North Opuha and South Opuha river flows. The turbidity sensor at depth was not working correctly from early May until it was replaced on 22 May 2023 (circled data).

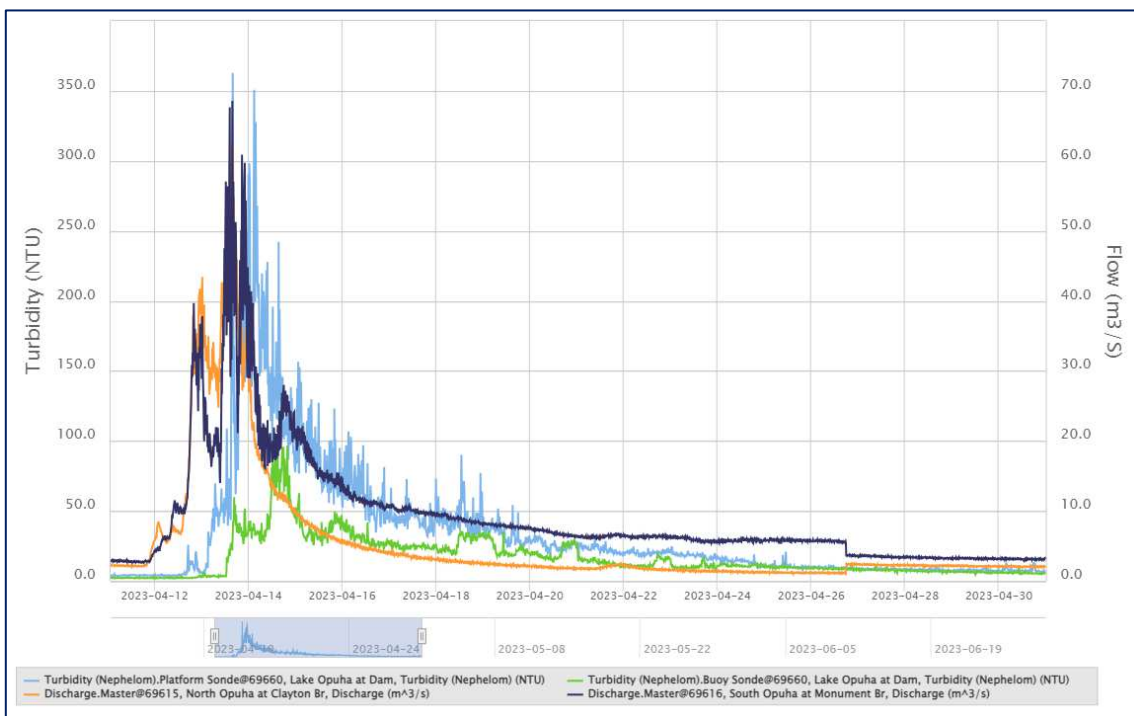
Increased inflows from the North Opuha River and South Opuha River (approximately 60 m³/s for both) during 12th April and 13th April 2023 resulted in increased turbidity at depth (>200 NTU) and at the surface (100 NTU) – Figure 3. Turbidity at the surface and at depth returned to <10 NTU around 12 days later on 26th April 2023.

Figure 3: Turbidity in Lake Opuha (depth and surface) and flows from the North Opuha and South Opuha rivers from 12 April 2023 to 30 April 2023.

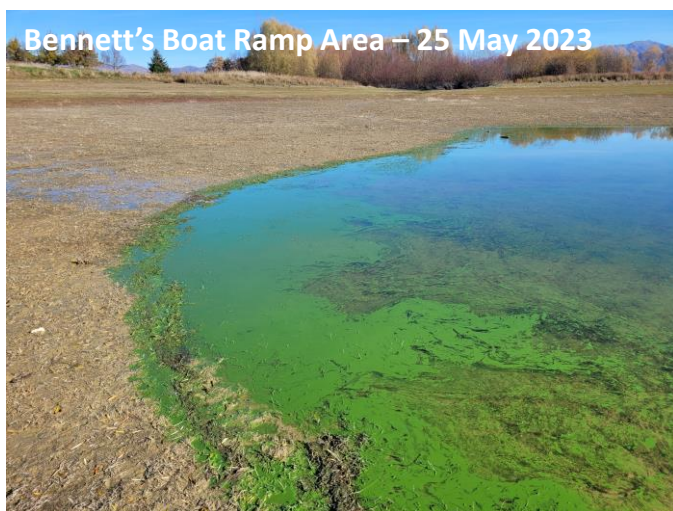
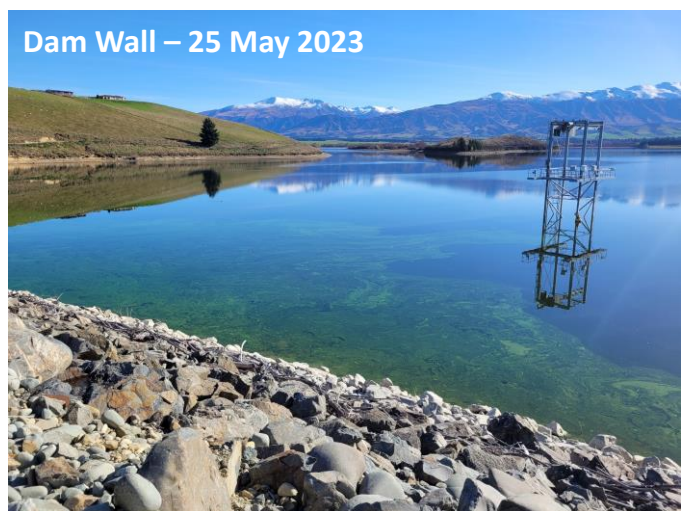
The cyanobacteria health warning issued on 1 March 2023 was still in place during the April – June period. Cyanobacteria scums were often observed at various locations in the lake (Figure 5) but high levels were never detected in the water samples collected at Bennett’s Recreational Reserve Boat Ramp or the Dam Boat Ramp. The health warning was removed in late July 2023 and further details will be provided in the 2023 July – September quarterly water quality report.

Figure 5: Cyanobacteria scums at Bennett's Boat Ramp Area and Dam Wall - 25 May 2023.

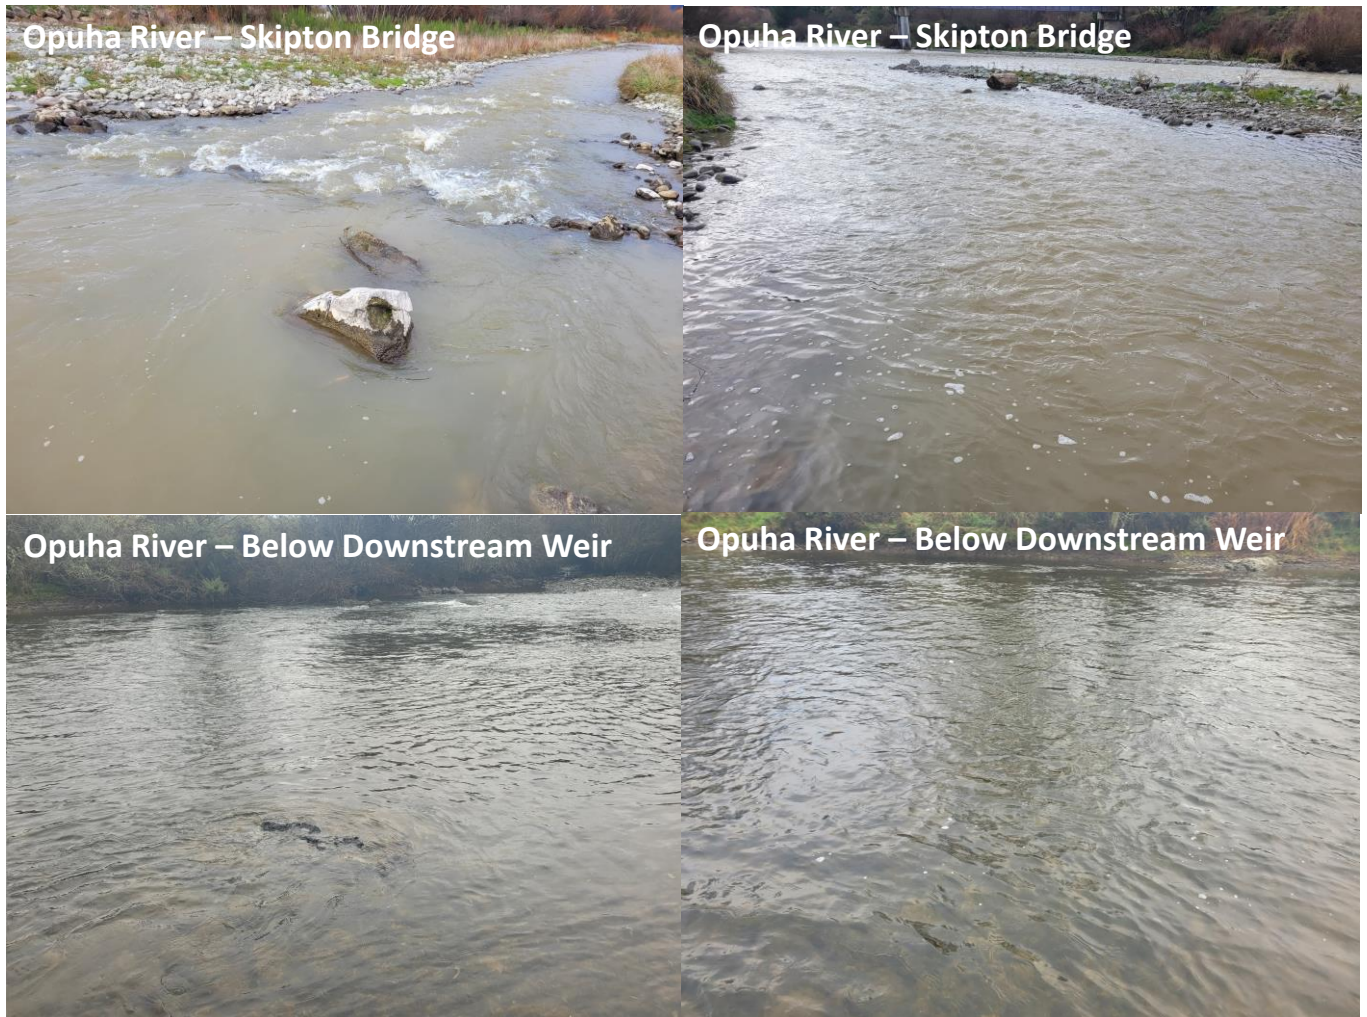
The 28 June sampling showed some interesting results and observations. The **water clarity** in the Opuha River at Skipton Bridge and the Gorge was considerably poorer than water clarity in the Opuha River below the Downstream Weir. The black disc measurement at Skipton Bridge and the Gorge was 0.14m and 0.1m, respectively, whereas the corresponding value for the Downstream Weir location was 1.9m. Photos of the Opuha River – Skipton Bridge and Opuha River – below Downstream Weir sampling locations (Figure 6) clearly show the difference in water clarity.

Figure 7: Photos of Opuha River – Skipton Bridge and Opuha River – Below Downstream Weir sampling locations on 28 June 2023.

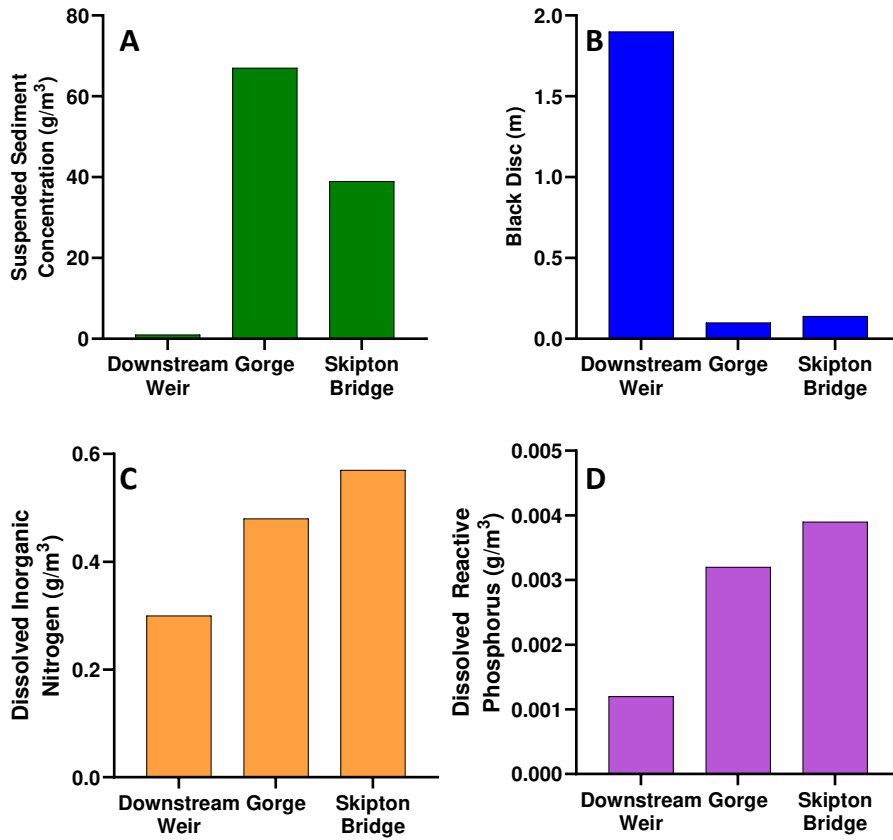
Laboratory results also showed differences between the Skipton Bridge, Gorge, and Downstream Weir sampling locations, with Skipton Bridge and the Gorge reporting higher levels for **suspended sediment concentration**, **dissolved inorganic nitrogen** and **dissolved reactive phosphorus** (Figure 8).

Figure 8: June 2023 water quality data for Downstream Weir, Gorge, and Skipton Bridge sampling locations for A) suspended sediment concentration, B) black disc, C) dissolved inorganic nitrogen and D) dissolved reactive phosphorus.

On 27 and 28 June 2023 there was rainfall within the general catchment, with 15mm of rainfall recorded at the Opuha Dam rainfall gauge. This rainfall affected the Opuha River at the Gorge and Skipton Bridge sampling locations but not the water quality in the Opuha River below the Downstream Weir – any low clarity water had not moved through the lake at the time of sampling.

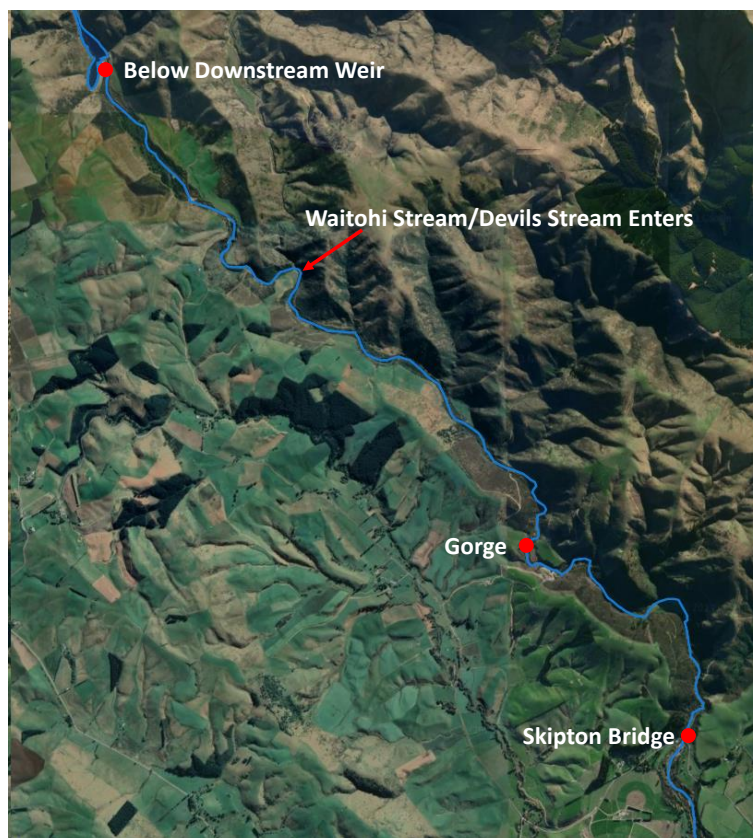
A subsequent investigation located a tributary of the Opuha River that was the likely source affecting the water quality at the Gorge and Skipton Bridge. Waitohi Stream/Devils Stream enters the Opuha River between the below Downstream Weir and Gorge sampling locations (Figure 9). Landowners within the region advised that Waitohi Stream/Devils Stream runs very dirty after rain events. OWL's current assessment of the situation is that this is not caused by the surrounding land use but, rather, due to riverbank destabilisation and erosion after the May 2021 weather event.

Figure 9: Sampling locations on the Opuha River and the point at which Waitohi Stream/Devils Stream enters the Opuha River.

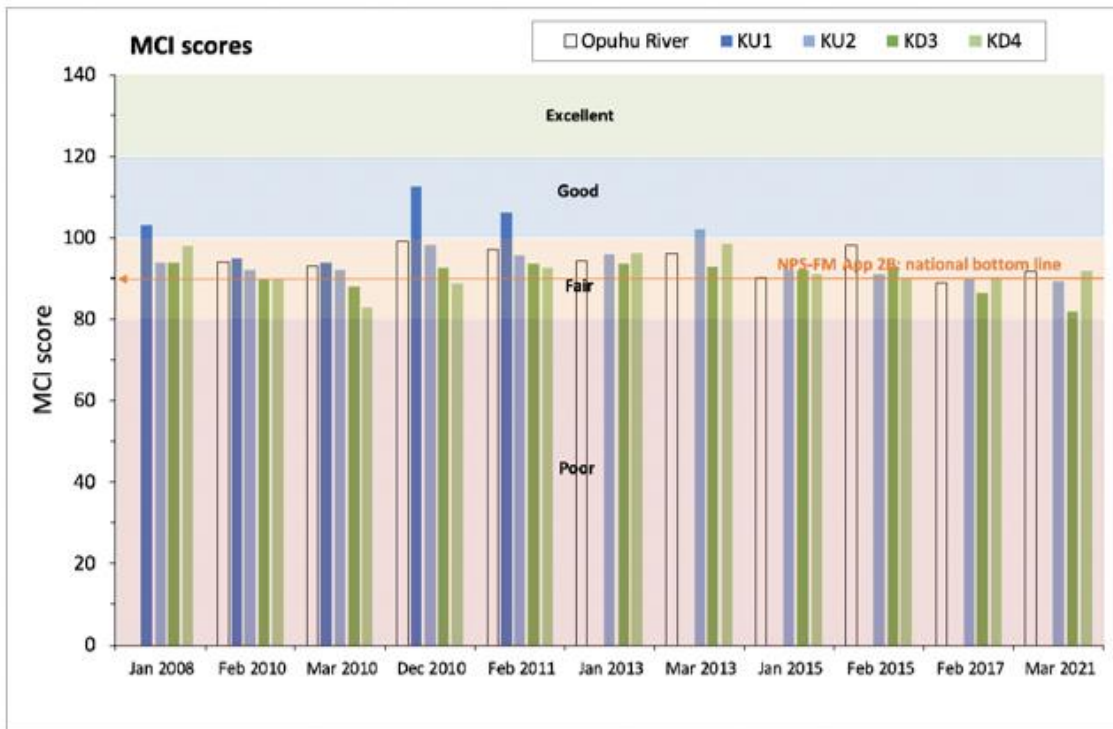
The **MCI** data from ecological surveys undertaken in the Kakahu River from 2008 to 2022 shows similar MCI scores upstream and downstream of the discharge (data from 2008 to 2021 – Figure 10), indicating that the discharge is having minimal impact on the presence of species within the macroinvertebrate community in the Kakahu River. The 2022 survey showed that the Winchester Hanging Rock Road Bridge (WHR) sampling location (furthest downstream sampling location) was significantly different to other sites (Figure 11), but this is more a reflection of the sampling location rather than the discharge, as WHR tends to have higher nitrogen, phosphorus and *E.coli* than other sampling locations, indicating other inputs within the catchment affecting the health of the Kakahu River.

Figure 10: MCI scores for Kakahu River from 2008 to 2021. Blue bars are for upstream sites and green bars are for downstream sites.

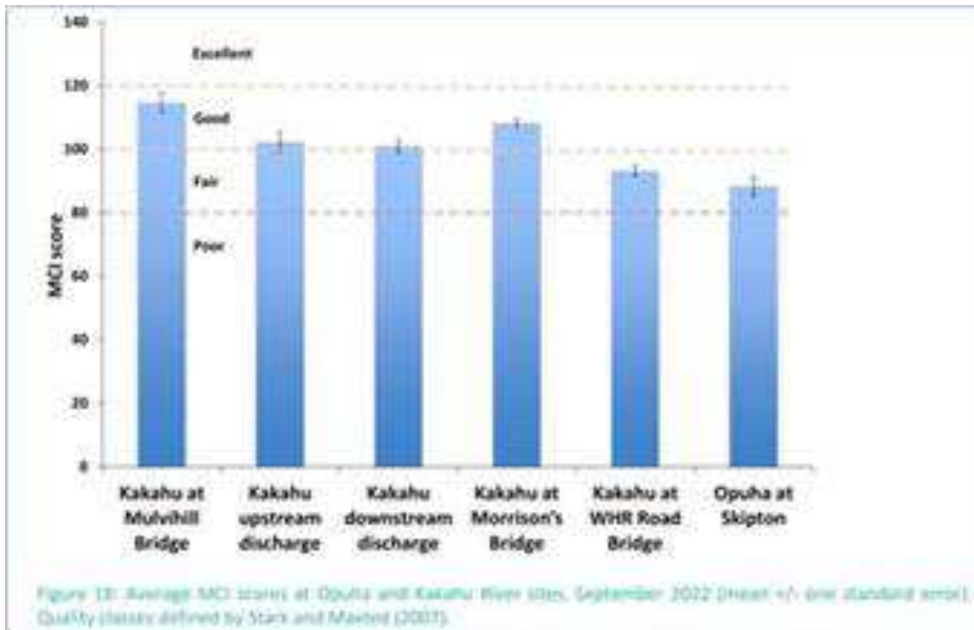
Figure 11: MCI scores for Kakahu River in September 2022.

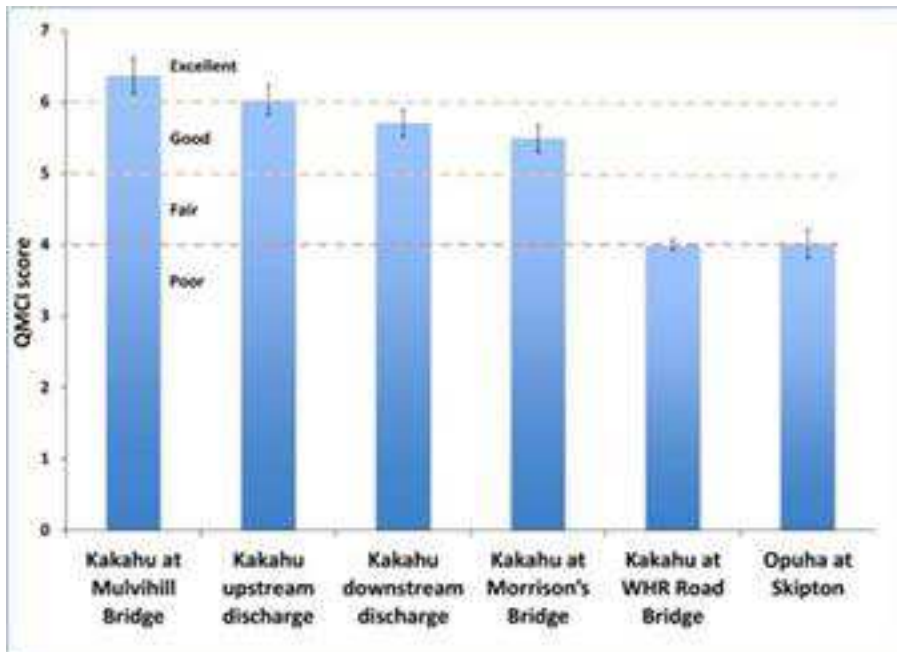
The **QMCI** data is not as clear as the MCI data, however it does show that in April 2022 and September 2022 there was no evidence to support claims that the discharge affects the ecological health of the river, with similar scores upstream and downstream of the sampling location (Figure 12). Again, the Winchester Hanging Rock Road Bridge sampling location was significantly different to other sites.

Figure 12: QMCI scores for Kakahu River in September 2022.
